Lab Notes

Extraordinary Large Bicolor Natural Rough Diamond

GEMS & GEMOLOGY, Vol. 61, No. 3, pp. 290–301.

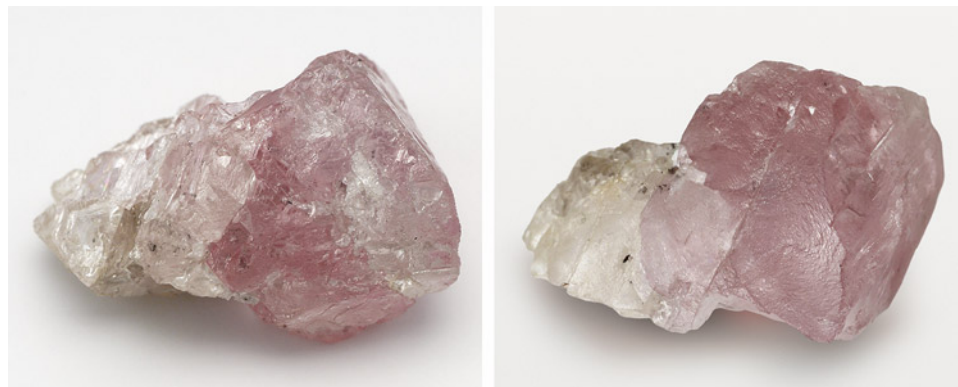
Figure 1. This 37.41 ct rough diamond has distinct pink and colorless zones. Photos by Tebogo Hambira.

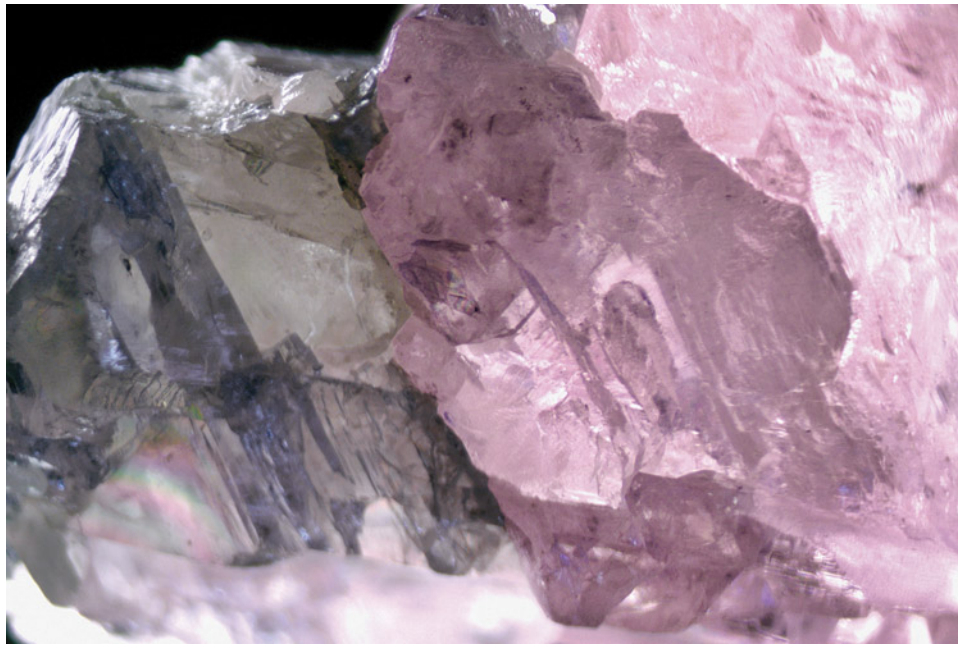
Figure 2. This boundary shows a sharp transition from pink to colorless zones. Photomicrograph by Wanling Tan; field of view 4 mm.

Sourced from the Karowe mine in Botswana, this rare find was submitted to GIA's Botswana laboratory for the GIA Diamond Origin Report service. The stone measured 24.3 × 16.0 × 14.5 mm and examination showed mostly a sharp boundary between the pink and colorless zones (figure 2).

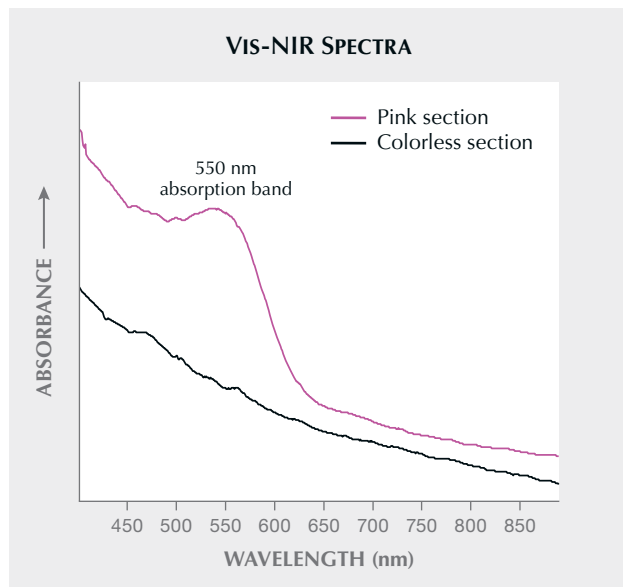
Figure 3. Comparison of Vis-NIR absorption spectra collected from the pink and colorless sections. Spectra are offset vertically for clarity.

Fourier-transform infrared absorption, visible/near-infrared (Vis-NIR) absorption, and photoluminescence (PL) spectroscopy along with deep-UV imaging were collected from both the pink and the colorless portions of the submitted diamond in order to better characterize its properties. The diamond was identified as type IIa with no observable differences in the IR spectra in the two sections. Vis-NIR absorption showed the 550 nm absorption band in the spectrum collected from the pink section; unsurprisingly, it was absent from the colorless section (figure 3). There were minor differences in features detected within the PL spectra collected with 457, 633, and 830 nm lasers, along with deep-UV fluorescence imaging when comparing data collected between the pink and colorless portions. However, the full peak width at half-maximum of the H3 center (NVN⁰; 503.2 nm) was significantly narrower in the pink section (0.61 nm) than in the colorless section (1.12 nm).

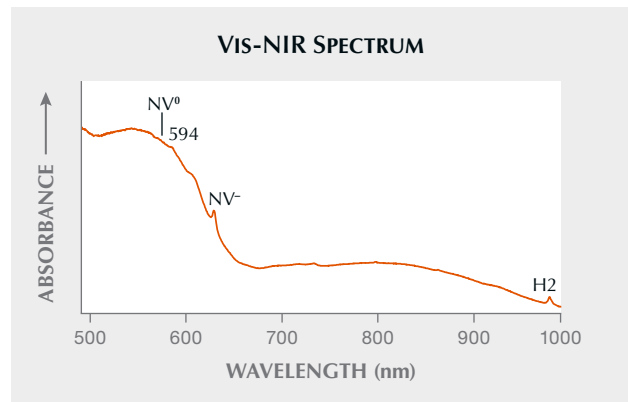
Figure 7. Vis-NIR absorption spectrum showing the 594 nm, NV^0 and NV^- (attributed to the pink color), and H2 centers, indicative of treatment.

The visible/near-infrared (Vis-NIR) absorption spectrum obtained from this diamond has typical spectral features of a treated diamond exposed to laboratory irradiation and heat treatments. These features include the 594 nm peak indicative of irradiation, the NV^0 and NV^- centers causing the pink color, and the H2 center indicative of heat treatment (figure 7). Deep-UV fluorescence images, as observed using the DiamondView instrument, show a combination of yellow and orange fluorescence; both of these fluorescence colors can be created by NV centers and the observed color can vary

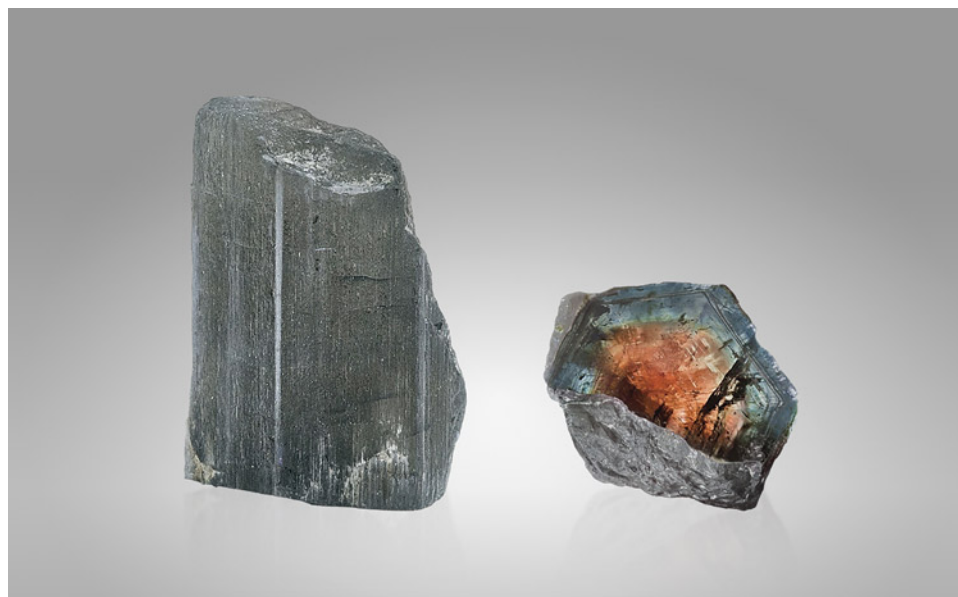
Figure 14. A 63.17 ct ($26.70 \times 17.24 \times 15.23$ mm) prismatic bicolor dumortierite rough crystal, viewed from the side (left) along with a cross-section view (right), displaying a pinkish orange core and a gray-blue outer layer. Photos by Lhapsin Nillapat.

Recently, GIA's Bangkok laboratory received a 63.17 ct partially polished rough crystal with a prismatic shape and hexagonal cross section, measuring approximately $26.70 \times 17.24 \times 15.23$ mm. The sample exhibited a uniform gray-blue color externally, with a strongly zoned bicolor core running along the length of the crystal featuring a pinkish orange center surrounded by a rim of gray-blue (figure 14). The color zoning was reminiscent of watermelon tourmaline's appearance, but in a different crystal form and color. The bicolored zoning observed in this dumortierite may be the result of a change in trace element composition during the crystal's growth.

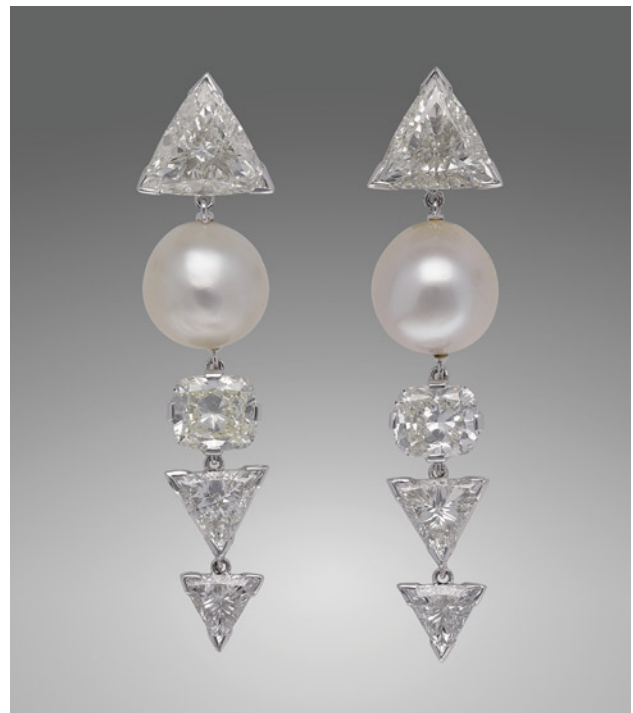
Figure 18. Two partially drilled button-shaped light cream assembled pearls weighing 7.40 and 9.37 ct, respectively, mounted in a pair of earrings. Photo by Gaurav Bera.

Recently, GIA's Mumbai laboratory received an intriguing pair of mounted pearl earrings, which were later unmounted for identification and concluded as assembled pearls. Both button-shaped pearls were partially drilled and exhibited a light cream hue. Pearl A measured 12.19 × 11.88 × 7.38 mm and weighed 7.40 ct, and pearl B measured 12.58 × 12.06 × 9.18 mm and weighed 9.37 ct (figure 18).
